Property Inspection Report

RR-7704692036

650 Pepper Wood Lane
Stone Mountain, Ga 30087

Roofing Remedies, Ltd.

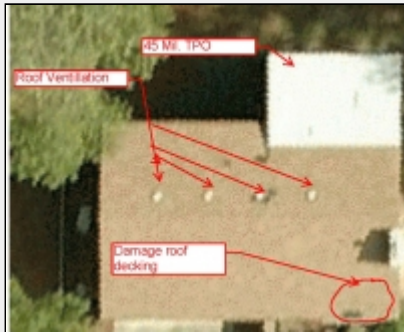
Remarks: Roof Shingle repair and roof deck damage front south corner

Roof : shows 4 RV50 Vents (air vents) Flat area of roof 300 Sq ft. Roll roofing membrane Damage roof decking front northeast corner Trees mostly cut back .

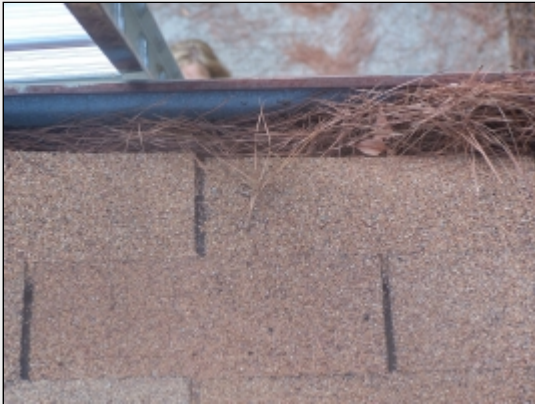
Debris need to be removed.

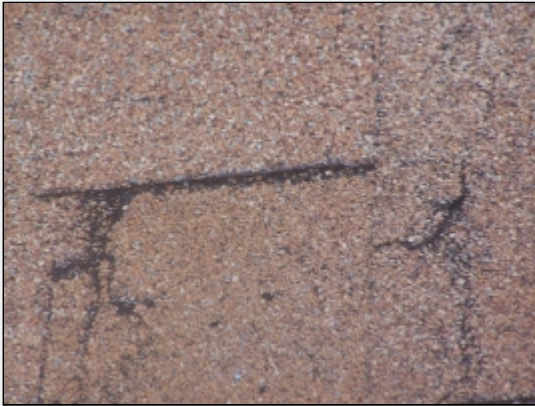
Comment: Shingle(s) are damaged.

caused by poor roof ventilation.

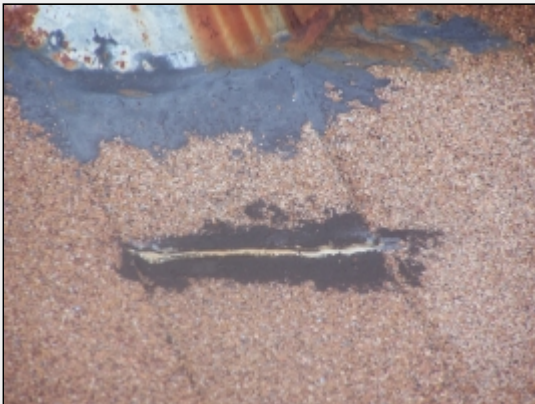
Improper mastic applied (should be applied under shingles and vent flashing

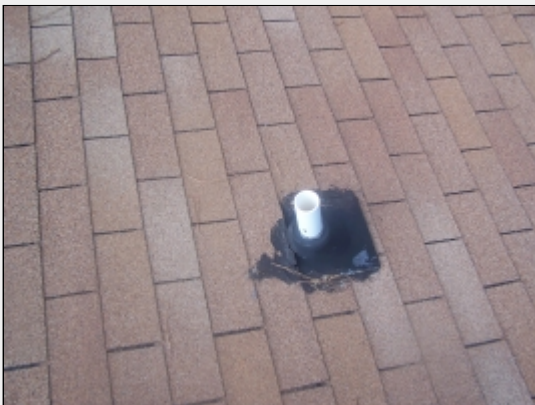
plumbing boot flashing damage and needs replacement

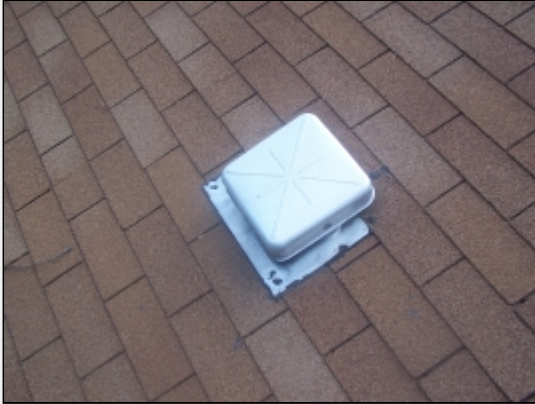
sealant properly install between flashing and shingle surfaces

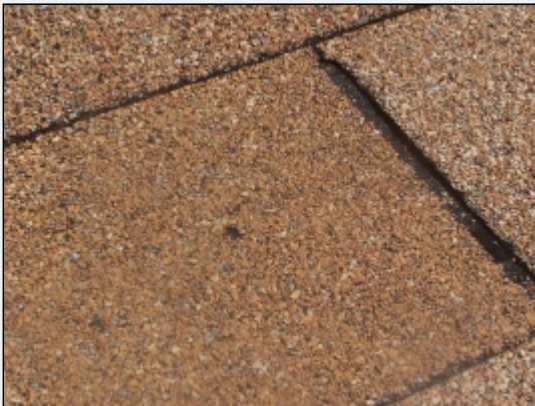
close up of shingle (their are small mineral surface of shingle missing)
CAUSED BY POOR VENTILATIONS

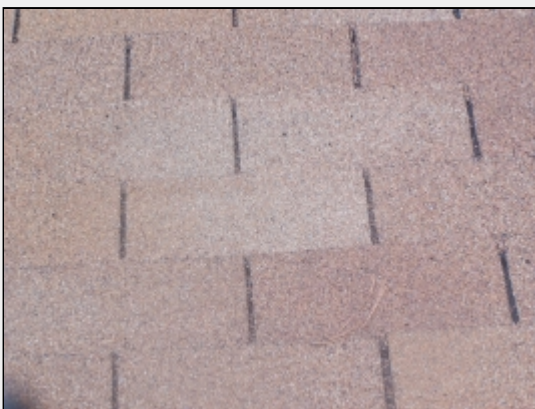
LARGER AREA OF SHINGLE SHOW
SMALL BLACK SPOTS (CAUSED BY
POOR VENTILATION.)

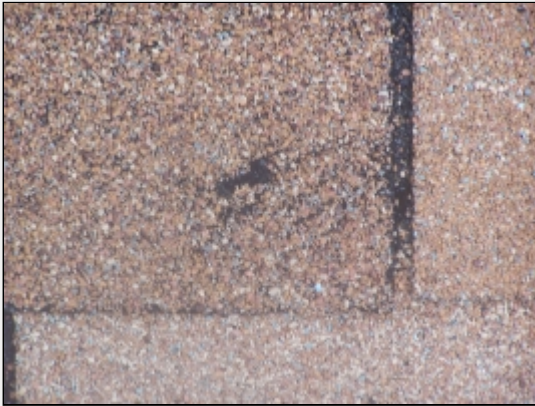
Comment: Shingle(s) are damaged.

Blister lost of mineral surface (excessive heat)

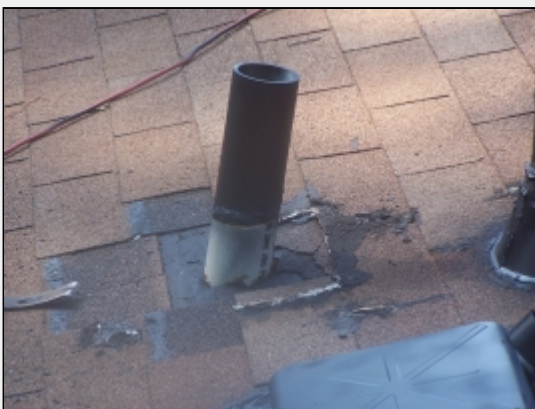
Before installed new

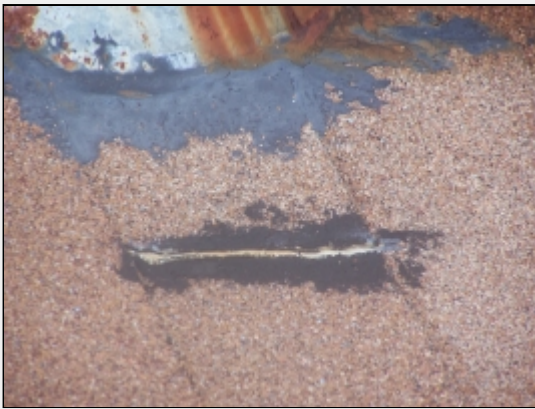
Comment: Galvanized vents rusted (paint using metal rust preventative paint)

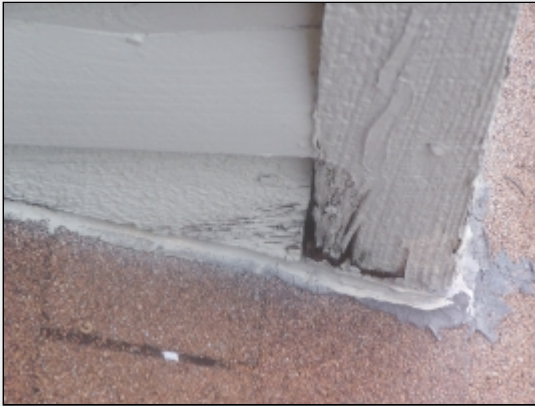
Comment: Damage chimney wood corner trim

Small area of trim rot (isn't covered under roof warranty) area should be repair at time of re-paint.

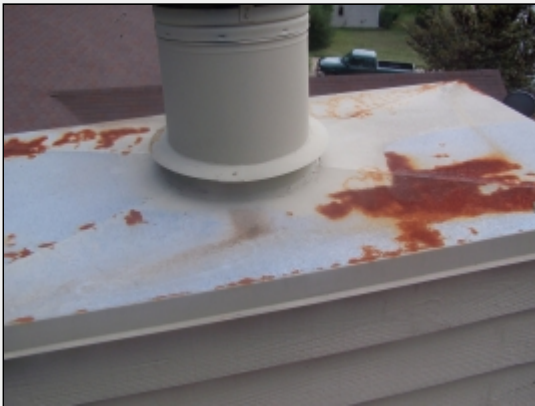
Comment: metal pan cover heat stack of chimney

Surface rust, paint to prevent rust , collar sealant good.

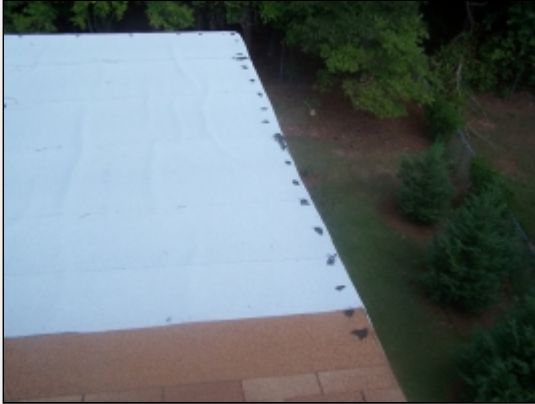
Comment: Bulged rolled roofing material observed in various areas.

exposed nails along rake of patio roof
Roof drains well and materials are newly installed , (life span expected 5 years)
Area of nails need to be sealed using mastic with mesh

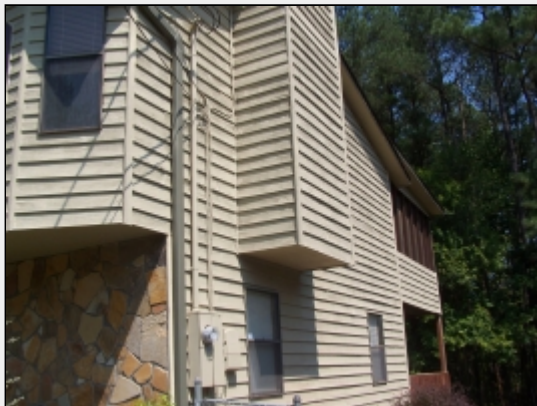
NEWLY PAINTED GOOD CONDITION

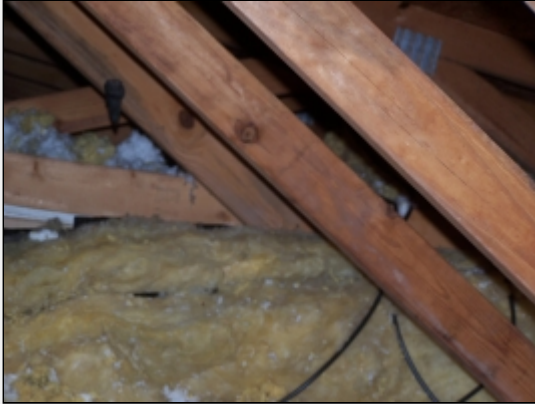
Comment: Blocked soffit and raised celing area of attic

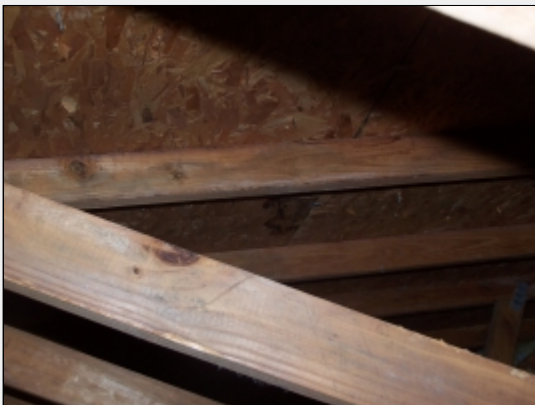
Comment: wet areas of OSB roof deck

small area wet at joint of OSB boards

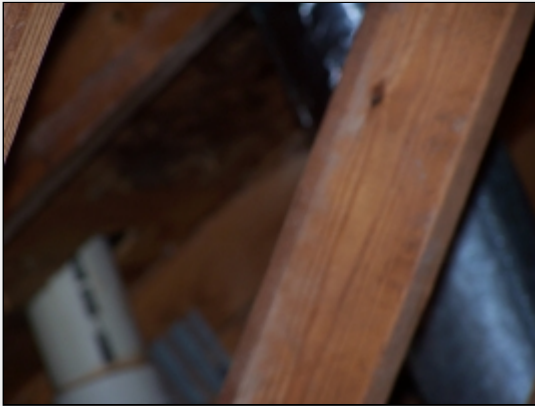
Comment: wet areas of OSB roof deck

large area wet at metal pipe (roof vent flashing)

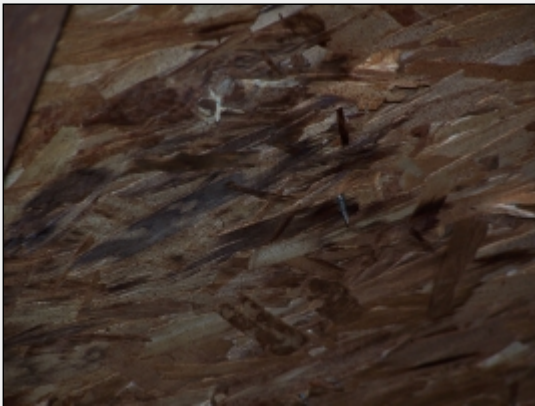
Comment: wet areas of OSB roof deck

area wet rear section of roof

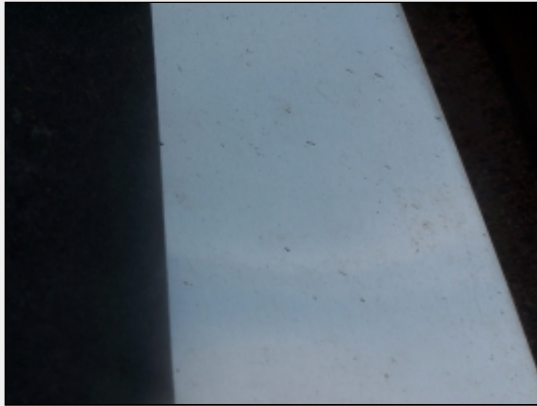
Over all decking is good it has areas of wet stains caused by roof leaks and photo here show area damage and need repair where rot and covered with sheet metal

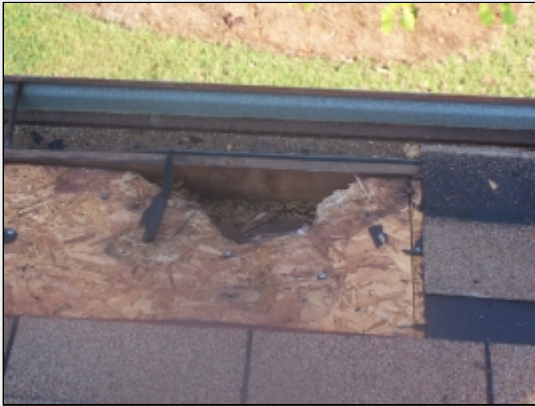
where metal place (by Frank) to cover hole in decking.

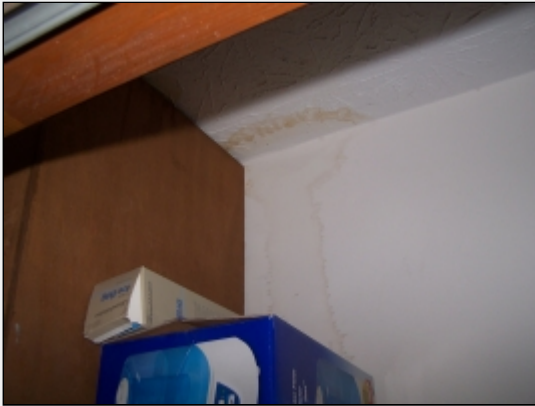
Water stain Closet

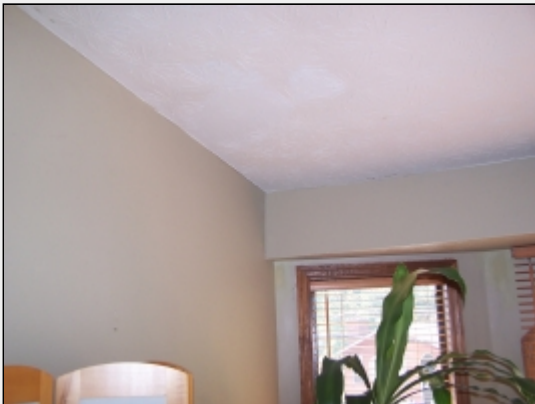
Comment: Prior drywall repair observed at

Area in corner (roof decking repair needed)

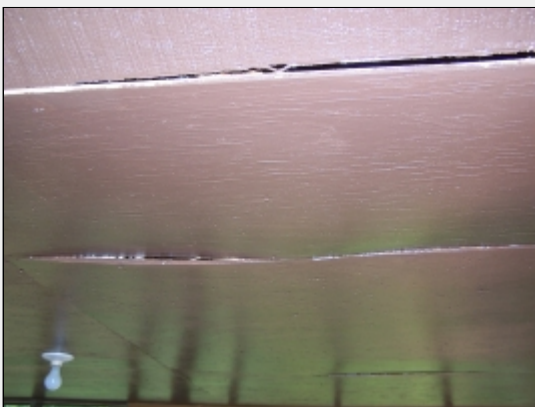
Buckle loose plywood ceiling rear cover porch.
