Roofing Remedies Ltd.

Title: Overview

Roof Details

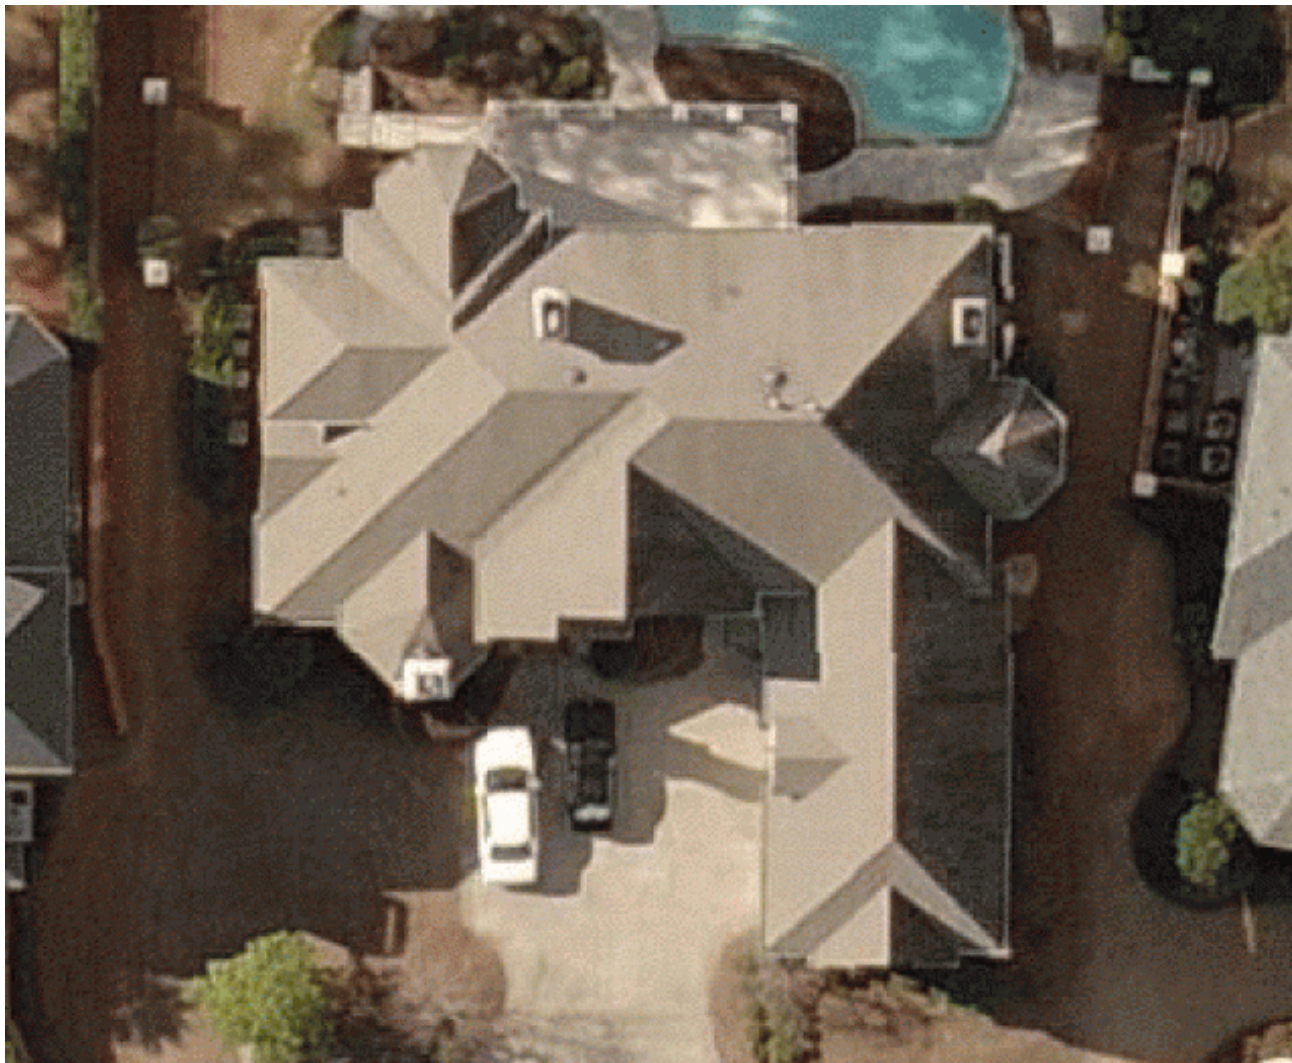
Actual Roof Planes	42
Billed Roof Planes:	56
Primary Roof Pitch:	12
Total Eaves:	360.0 ft
Total Rakes:	126.7 ft
Total Ridges:	150.0 ft
Total Hips:	367.4 ft
Total Valleys:	278.4 ft
Chimney:	57.1 ft
Step Flashing:	51.9 ft
Apron Flashing:	28.4 ft
Gutters:	195.1
Area Total (3:12 & Greater):	6,606.2 sq ft
Total Area:	6,606.2 sq ft

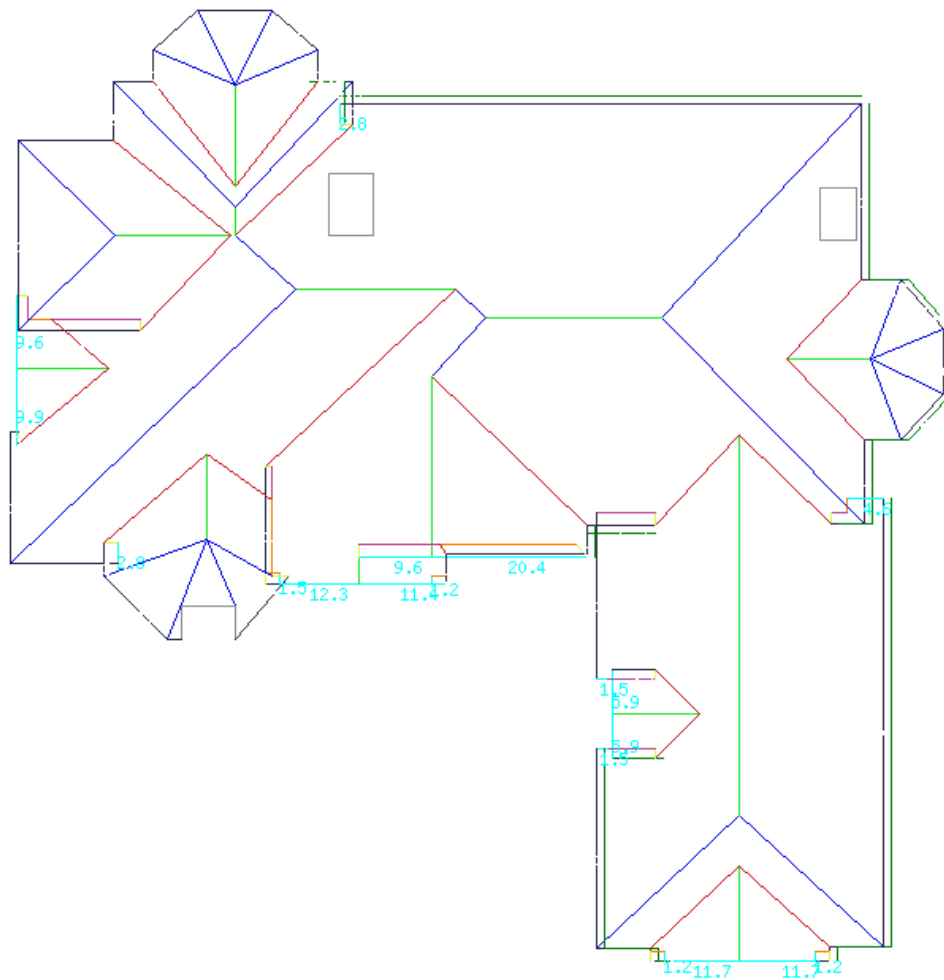
Title: Rakes Diagram

Roof Edges

Edge	LF
Eaves	359
Rakes	129
Ridges	151
Hip	366
Valley	279
Chimney	56
Step Flashing	51
Apron Flashing	27
Gutters	194 ft

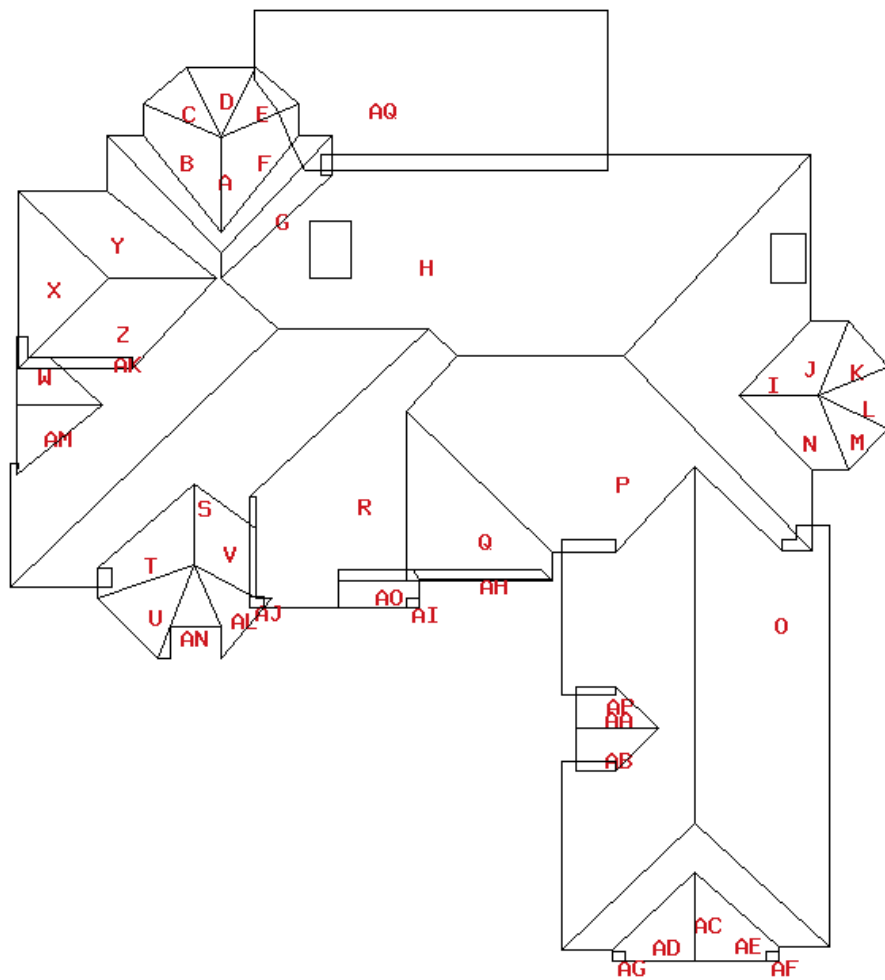
Title: Area Diagram

Roof Facets

Plane	Pitch	Area
AQ	1	534 SF
Sub Total	1	534 SF
A	12	78 SF
AA	12	35 SF
AB	12	35 SF
AC	12	144 SF
AD	12	58 SF
AE	12	59 SF
AF	12	2 SF
AG	12	2 SF
AH	12	16 SF
AI	12	2 SF
AJ	12	2 SF
AK	12	439 SF
AL	12	34 SF
AM	12	42 SF
AN	12	25 SF
AO	12	42 SF
AP	12	605 SF
B	12	67 SF
C	12	30 SF
D	12	35 SF
E	12	30 SF
F	12	67 SF
G	12	51 SF
H	12	1,145 SF
I	12	423 SF
J	12	61 SF
K	12	30 SF
L	12	29 SF
M	12	29 SF
N	12	60 SF
O	12	688 SF
P	12	586 SF
Q	12	200 SF
R	12	403 SF
S	12	445 SF
T	12	76 SF
U	12	54 SF
V	12	65 SF
W	12	42 SF
X	12	112 SF
Y	12	120 SF
Z	12	140 SF
Sub Total	12	6,606
Total Area		7,140
Area Total (0:12 to 2:12) :		534 SF
Area Total (3:12 & Greater) :		6,606 SF
Steep Roof(10:12 to 12:12) :		6,606 SF
High Roof:		4,513 SF

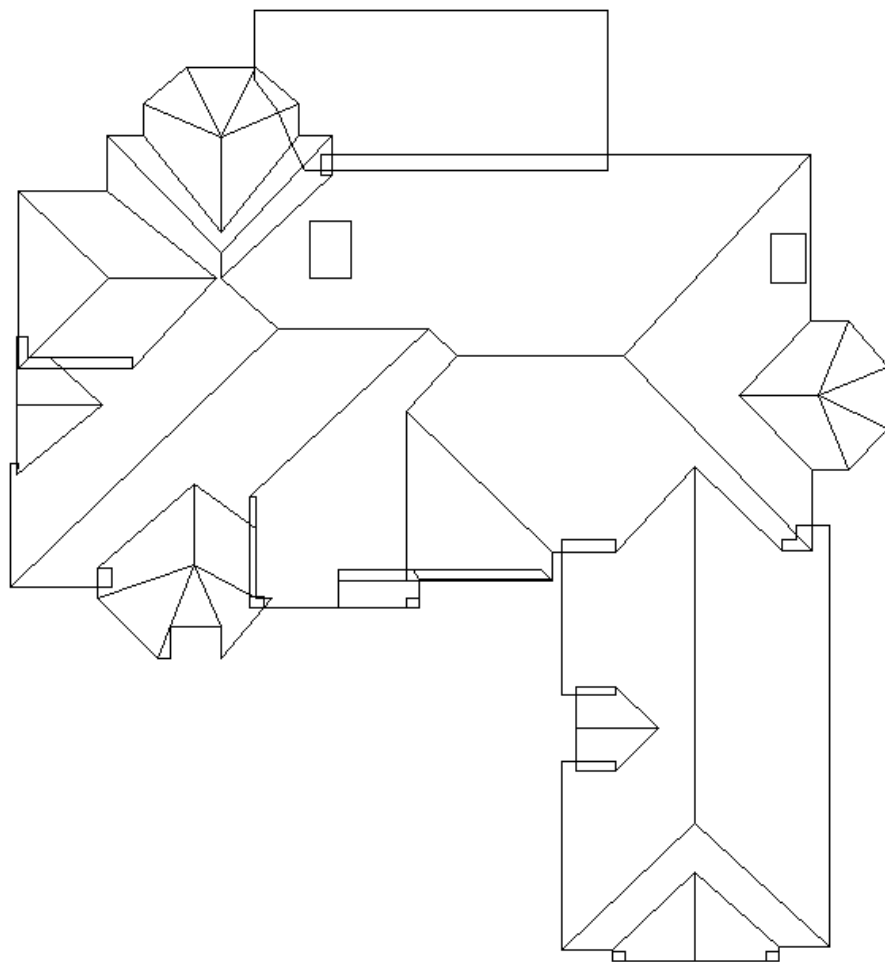
Title: Notes

Notes

A Rear area Low slope to be roof addition add
to cover existing deck Roof slope to be 1/12
with single ply TPO membrane roof system
Aluminum 6 inch gutter and 4 inch
downspouts Structure to be #2
lumberColumns to match lower (stucco with
archer between
